## Case Study: Telephone House

Telephone House is a large office complex located in central London close to the Embankment. The building, which dates from around 1900, is listed due to its special architectural interest. Guardian Water Treatment was asked to investigate the building's LTHW system in 2017 due to a number of issues that had arisen.

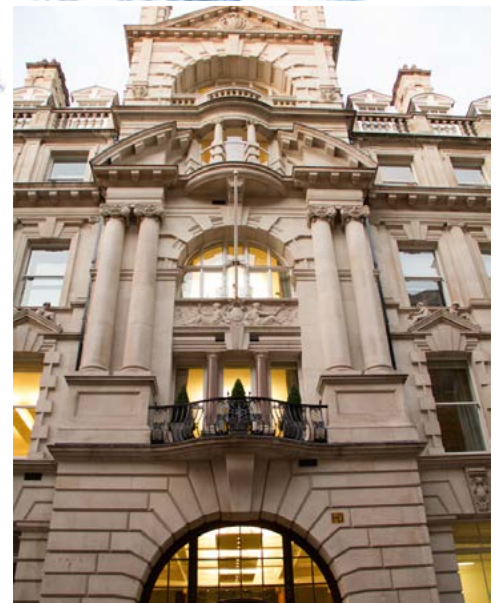
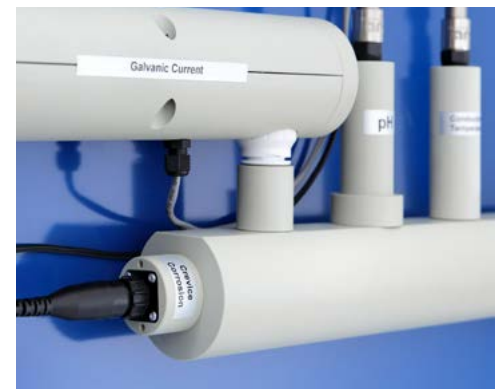
Historically, the radiators throughout the building had been leaking on a regular basis – every week in fact. Although the BSRIA Chemistry and bacterial results were in guideline limits and iron levels and solids were also in spec, this leakage suggested another cause of corrosion, one not picked up by the usual sampling methods.

Midland Corrosion's detailed analysis cited Gross Aeration as the problem when they discovered oxide deposits in the radiators' water channels. At some point, oxygen had got into the sealed system. How or when this had happened wasn't clear; the system could have been partially drained down for an extended period during commissioning. Whatever the cause, the pressing issue was to get on top of the problem before it started to do real harm to the system, which could potentially lead to costly repairs and operational downtime. Flushing – which is many engineers' standard reaction to closed water system issues - in this instance would not have been effective.

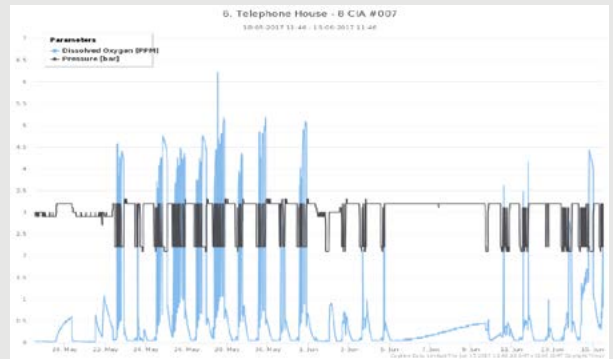
Graph 1

**Graph 1** – shows the same DO and pressure over the whole monitoring period – apart from the first week and the period from 5-11th June, the pattern is repeated and the peaks and troughs are consistent with heating /standby periods (i.e. pumps or boilers on/off cycles).

DO in a stable system wouldn't normally rise above 0.2ppm and the graphs would show less fluctuation if the system was stable. As conductivity remained stable throughout the period there weren't any significant water losses or gains.

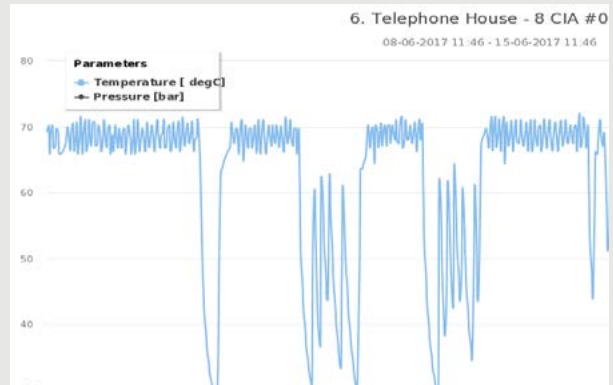
Graph 2

**Graph 2** - shows the pattern of pressure in relation to the temperature of the LTHW system.

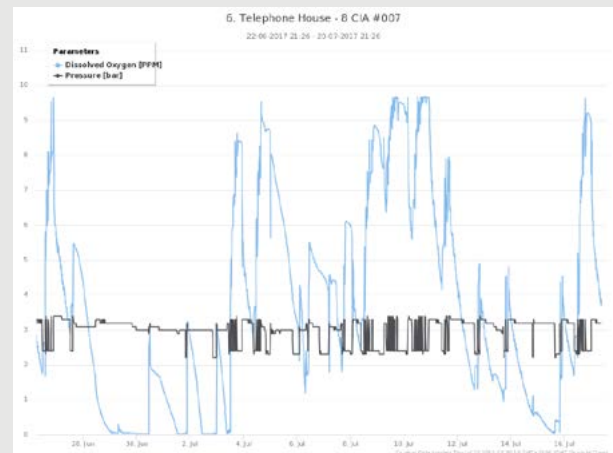
Graph 3

**Graph 3** – shows the dissolved oxygen (blue) and the pressure (black) as measured at the base of the system. The oxygen levels peak every time the pressure drops.

Between 28 June and 4th July, indicated by an arrow, the pressure doesn't drop far from the 3.3Bar level and during this period the oxygen levels remain mostly low and more stable. When the pressure is less stable and drops below 3 bar, oxygen levels rising again, peaking at 8ppm.

From this data we can see that at a higher resting pressure – or stabilisation of the resting pressure – restricts the ingress of fresh oxygen.

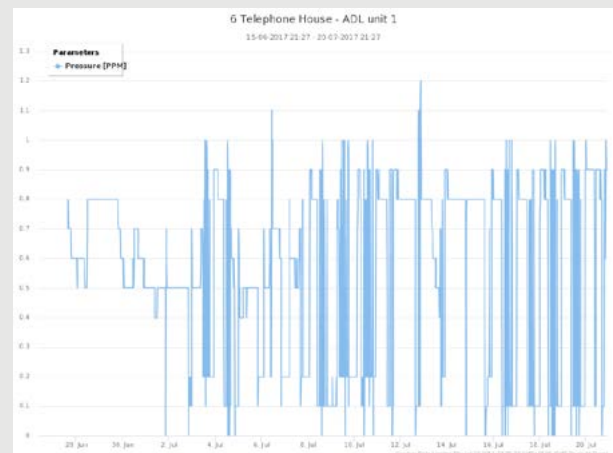
Graph 4

**Graph 4** – shows the pressure recorded in the upper plant room sensor on the 4th floor. (measured in bar). The arrow shows the same “stable” period as the graph above.

Several times the pressure drops to 0 bar indicating negative pressure and air ingress on the 4th floor.

As suggested at the end of phase one, the pressure on the 4th floor is dropping low enough to cause air ingress and this is the source of the dissolved oxygen. The stable higher resting pressures from 28th June-4th July show a far lower oxygen ingress.

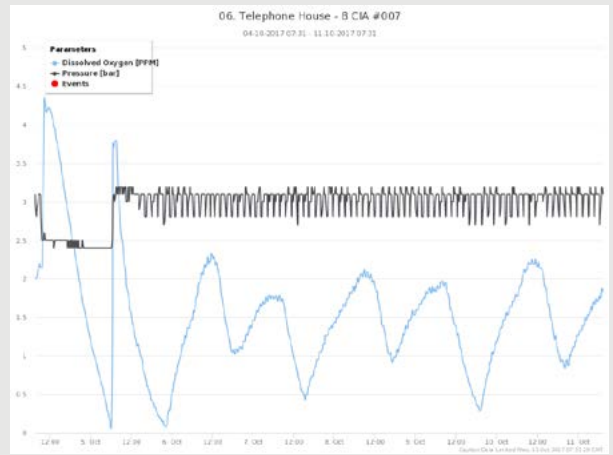
Graph 5

**Graph 5** – The readings taken at the end of the period, show that there is some stability in the system over the seven days (3rd – 10th October) although the DO is still higher than desired. During this period there are no dramatic drops in base pressure, stopping the peaks in DO.

During this period work had been carried out to address some of the mechanical issues on the system. The expansion vessels were serviced and a fault was found with one of them. This was rectified in early August. The Air/dirt separator was also replaced on around the 28th September.

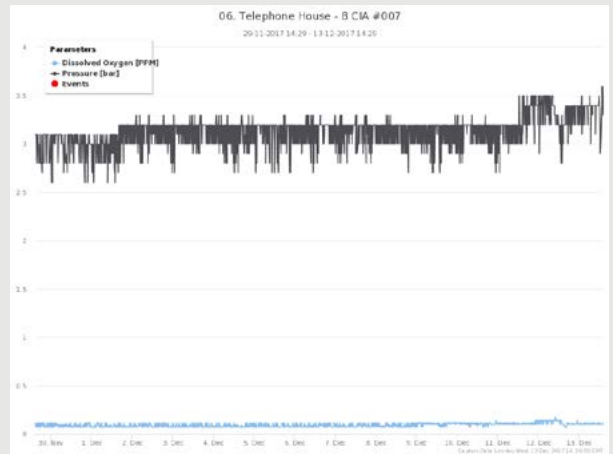
Graph 6

**Graph 6** – The oxygen has fully stabilised, the system is healthy.
