**Case Study:**  
**Building no. 6 - 24/7 monitoring vs sampling and corrosion coupons**

**The project**

Building no. 6 had a heavily contaminated Chilled Water (CHW) system, with high levels of dissolved iron (108mg/l) and suspended solids (138mg/l) identified. A large, occupied building, implementing a full flushing or re-cleaning programme was deemed impractical as there are over 500 Fan Coil Units and only limited out of hours' access would be available. Any works carried out ran the risk of destabilising the system.

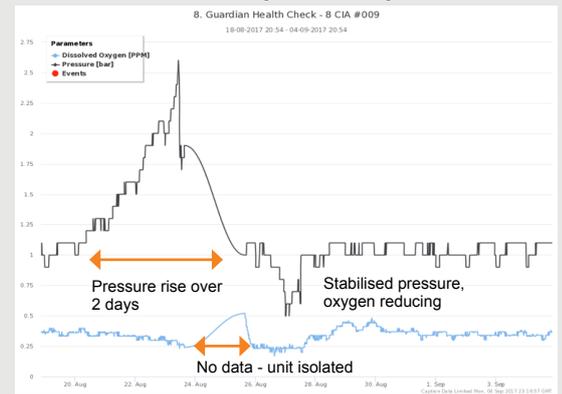
## Data before and after pressure spike

Within the first two weeks of installation the Hevasure system tracked pressure spikes and the actions and system conditions that had caused them. At the time, the site engineers noticed noise and possible air in the system – an indication that a previously non-circulating area had been re-opened and was introducing air. Due to the identification of this pressure spike, the unit was isolated temporarily until the cause was deduced.

Once the pressure spike issue had been resolved, DO returned to 0.33ppm and the corrosion sensors remained stable.

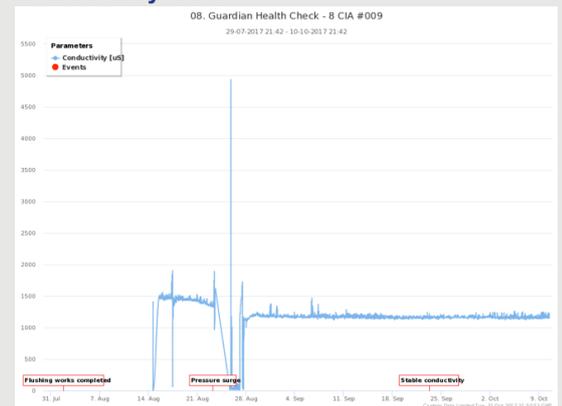
## Conductivity data

## Conductivity showing as stable after the pressure surge incident.

Following the pressure surge, around 400 litres of water had to be introduced to the system, causing a light drop in conductivity (28th August).

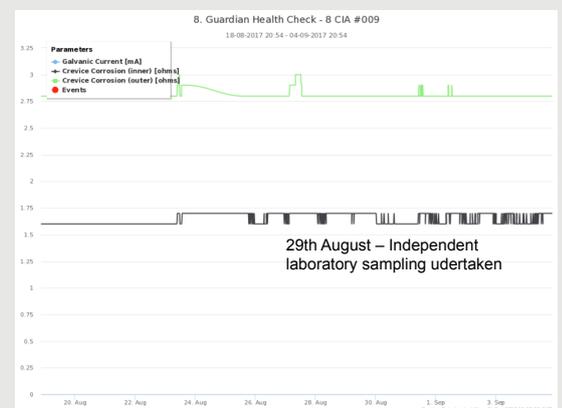
## Corrosion data

Providing readings every 15 minutes, all the indications from the Hevasure unit showed that the system was stable and that corrosion had been passivated, with the three different corrosion sensors showing non-activity following the flushing works.
