## Case Study: Telephone House

Telephone House is a large office complex located in central London close to the Embankment. The building, which dates from around 1900, is listed due to its special architectural interest. Guardian Water Treatment was asked to investigate the building's LTHW system in 2017 due to a number of issues that had arisen.

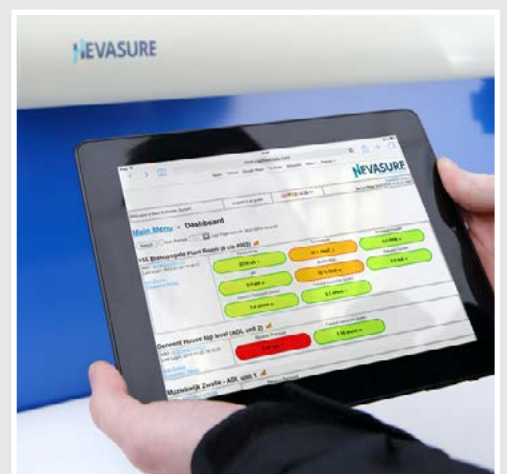
The results taken from graphs created over the period indicated that insufficient water pressure on the 4th floor was the problem. During every "standby" period, when the water was cooler, the pressure dropped and the oxygen levels spiked. Conversely, when the system was hot and the pressure stable (3.3bar basement, 0.7bar 4th floor) the DO levels were seen to reduce and stabilise.

Following this analysis, Guardian was able to recommend that the client investigate the matter further leading to the identification of air ingress that pointed to fixes to the expansion vessels, pressurisation units and AAVs. The system resting pressure and operating parameters were also reviewed. Once the pressure had stabilised and the DO levels were kept in check, corrosion rates became negligible and the inhibitors worked effectively.
